# Roof Inspection Report

Date of Inspection: 2/24/20

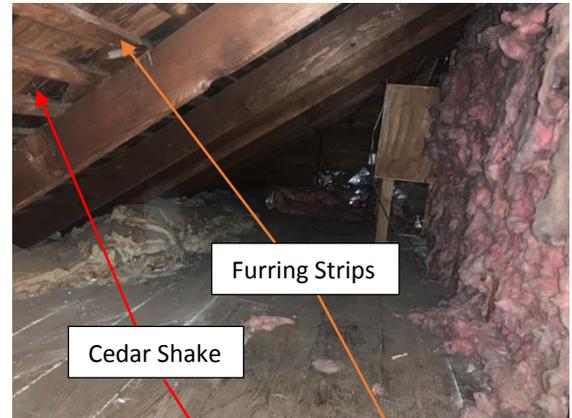
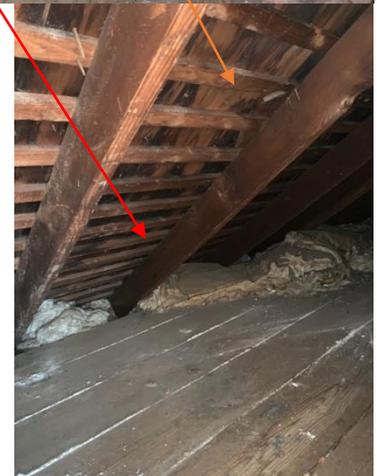
The accessible knee-wall on the 3<sup>rd</sup> story of the house clearly shows the decking for what is likely the original structure. The only sheathing is a layer of cedar shake nailed directly to furring strips. The cedar shake was damp to-touch throughout the area. Of the 19 Square on the main dwelling, about 11 Square is made up of this type of decking.

The single-story rear addition has vaulted ceilings, so there is no visible sheathing from inside. Some plywood can be seen from the outside and there is very little evidence of leaking (see Roof Penetration section), so it can be assumed that the roof sheathing can be salvaged in this area.

A new roof can't be installed over furring strips, so after the layers of roof and cedar shake are removed 5/8" CDX Roof Sheathing should be installed to support new roof system for the 11 square of cedar shake.

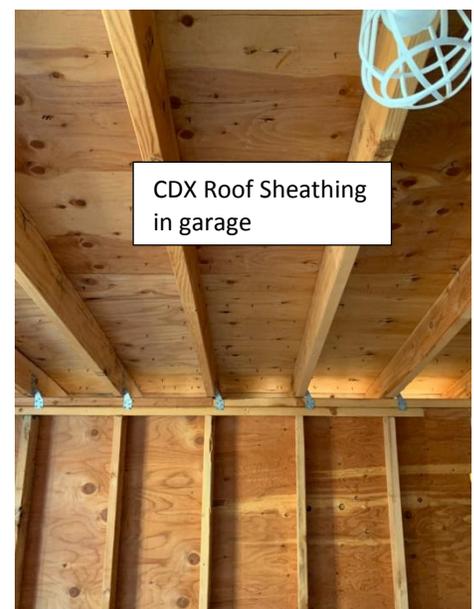
The detached garage has proper roof sheathing. The sheathing can be observed inside the garage and appears to be in like-new condition.

There is no evidence that any of this decking will need to be replaced during the roof's replacement.

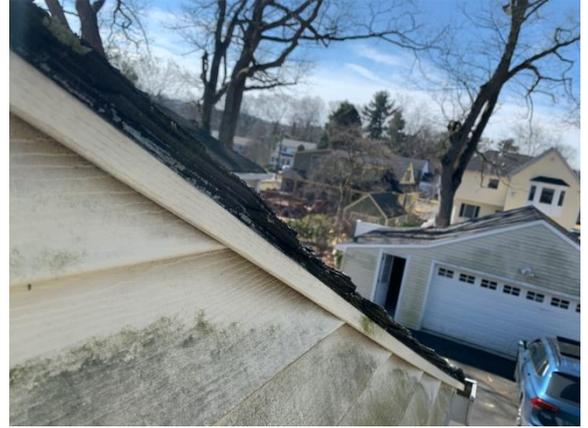
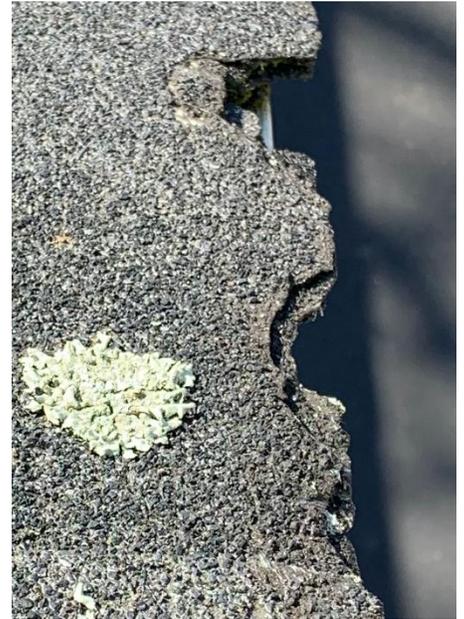
There are several areas on the main roof where the edges of the shingle are exposed. There is no evidence of ice/water shield barrier on any parts of the roof. This contributes to the granule loss by making it nearly impossible for the old shingle to completely dry.

The layers of roof shingle installed over top of the cedar shake don't seem to have any underlayment. Many areas are dry rot and broken, revealing the lack of underlayment.

There is tar paper present on the garage roof.

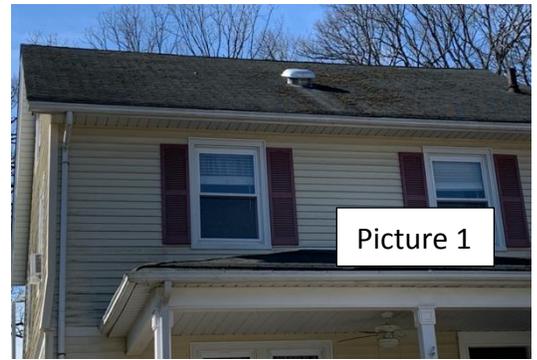
The attic fan is made of a zinc infused galvanized material which kills algae as it grows. There is a streak underneath the fan where the rain runs off of the roof and it is clear from the street that the rest of the roof is completely covered with black algae (picture 1).

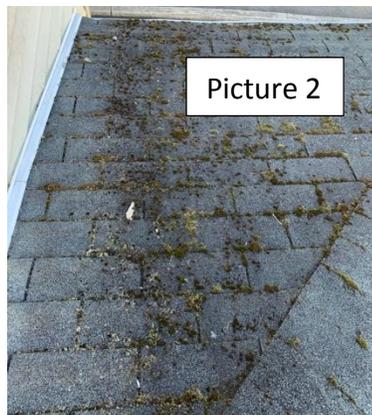
The front porch roof is covered in both algae and moss (picture 2)

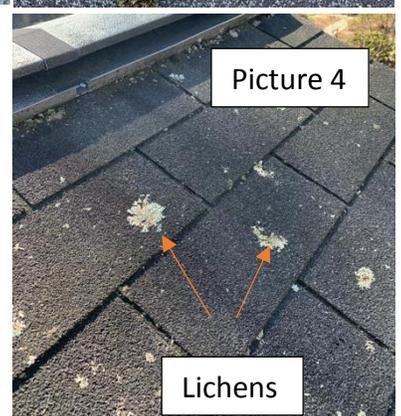
Lichens (a severe algae growth organism) are growing on many areas of the rear roof on both the original structure and on the addition (picture 4). Lichens grow mostly in areas where granules have fallen off the roof shingle. Lichens can sometimes be killed but can't be removed without

damaging the shingle. The lichen growth may be related to the ventilation of these areas. The rear addition roof should be replaced, and the presence of proper ventilation should be confirmed to avoid damage to the roof sheathing that is likely still in good condition.

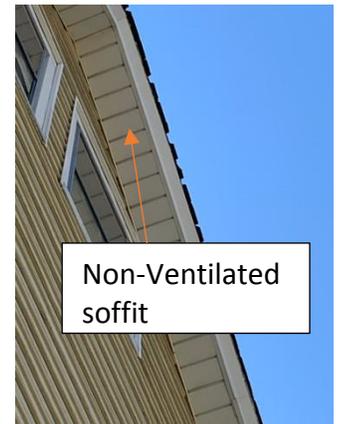
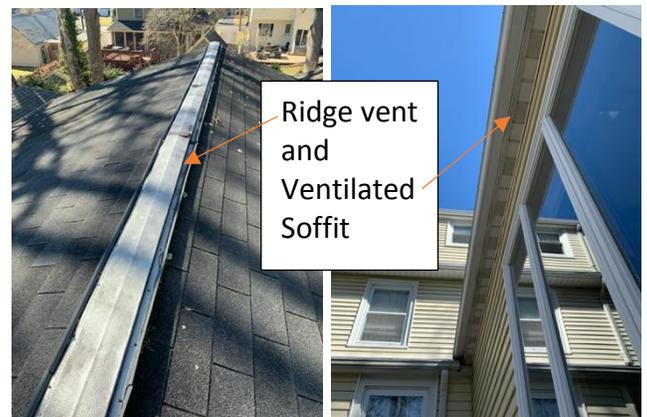
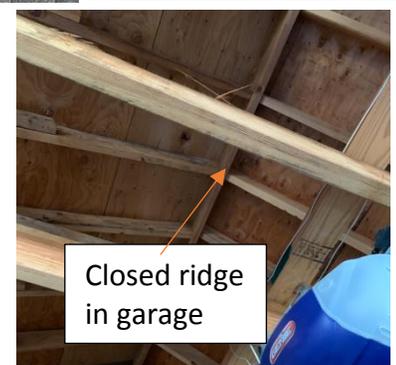
On the original structure, there is no ventilated soffit or any other forms of fresh air intake. There is an attic exhaust fan located in the knee-wall attic, but without any open areas for fresh air intake there is no fresh air coming from outside to replace the air passing through the exhaust. When the fan turns on, it will pull air from the living space of the 3<sup>rd</sup> floor which causes waste and inefficiencies in heating and cooling the house.

The soffit areas in the knee wall attic are also clogged with fiberglass insulation (see photos in Decking section) which would cut off the intake of fresh air, even if the soffits were open and vented from outside. During the roof's replacement, the soffit can be ventilated, the fiberglass blocking the intake can be cleared, and a baffle system can be installed to allow the fresh air to pass from the soffit to the ridge. Using that method, the attic fan can be removed to avoid the maintenance and remove the negative curb appeal of the fan being visible from the street (see photo in Algae and Moss section). If there is an obstruction that blocks the installation of a baffle system, the fan can remain and will work properly along with the open soffits.

There are open soffits in the garage (see photo in Decking Section) which allow fresh air to pass into the garage, but a ridge vent should be installed to avoid moisture issues that could deteriorate the plywood during humid months. Ridge is currently closed but is easily cut back during roof replacement.

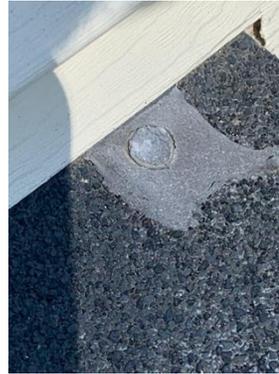
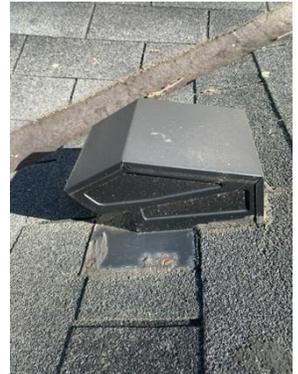
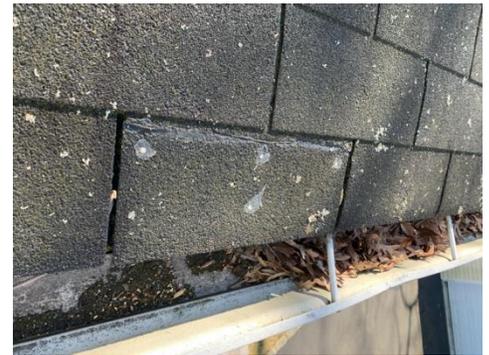
There are several areas where the existing shingle was face nailed and poorly sealed. Face nailing shingle is almost never necessary, but in cases where it is needed, the sealing of the nail is extremely important. The nails will leak, rust, and pop, leaving the roof system vulnerable to leaks and blow-offs.

The rear addition bathroom vent was installed over top of the shingle which caused a leak around the fan (see photo in Interior of House section). All pipe boots around house need to be removed and replaced during the roof replacement.

As noted in the Ventilation section, the attic fan should be removed, and the hole should be covered with new plywood if the baffle system can be installed without obstruction.

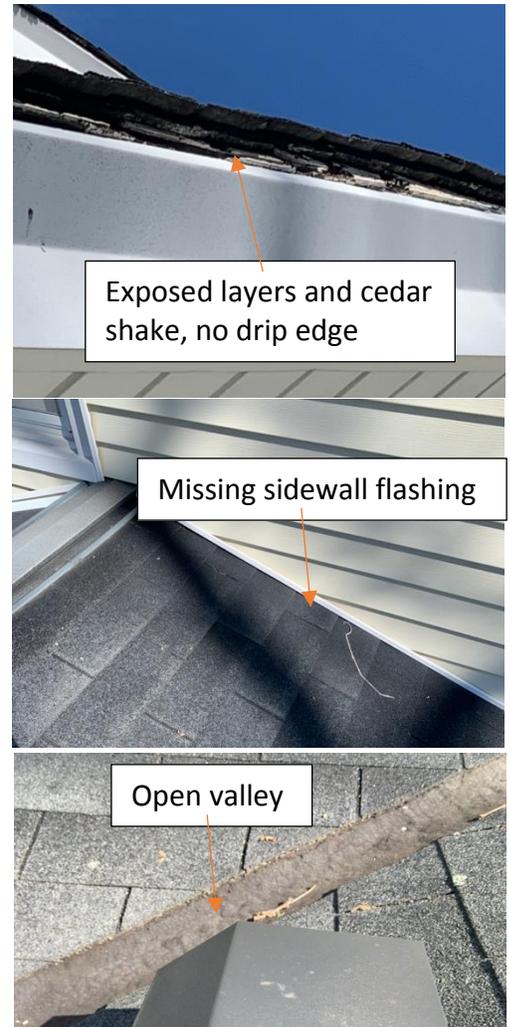
There is no drip edge on the roof. The entire roof is exposed to water on the edges.

The flashing is incomplete in several areas and non-existent in others. The siding needs to be removed in sidewall areas so that proper step flashing and ice/water barrier can be installed. The siding would then be re-installed.

The valleys are open and there is no metal to protect the decking. Currently, there is just thick layers of tar.

When the roof is replaced, the valley would be protected by ice/water shield and shingle. All of the existing flashing on the house should be removed and replaced to assure proper installation.

The garage roof needs drip edge installed when the roof is replaced.
