# Roof Inspection Report

Date of Inspection: 2/24/20

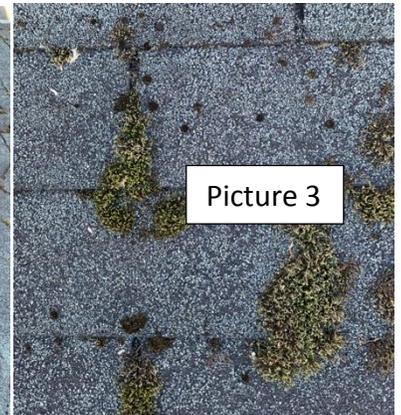
Garage Roof: The garage roof is covered with algae and has some lichen growth. Before the garage roof decking is harmed by the saturated shingle, this roof should also be replaced.
